## DAILY ACTIVITY REPORT

Report # 2

DATE Jan 20, 2017

<b>TASK:</b>	<input type="checkbox"/> Industrial Area Soils	<input type="checkbox"/> Industrial Area Groundwater	<input type="checkbox"/> Surface Water	<input checked="" type="checkbox"/> Sediment	<input type="checkbox"/> MIS
<b>SUBCONTRACTORS/VISITORS ON SITE:</b> Tim Thompson (SEE); David Browning (BES); Kim Hawkins (HDR); Hailey Fitterer (HDR); Ellen Brown (USACE); Dale Dickinson (MSS); Bill Jaworski (MSS)					
<b>EQUIPMENT ON SITE:</b> MSS R/V Nancy Anne, MSS vibracore system					
<b>WORK PERFORMED (INCLUDE ANY SAMPLES COLLECTED):</b> <ol style="list-style-type: none"><li>Collected cores at FSP-designated stations. Cores collected, brought onboard, and transported to ARI for processing on 1/25/2017. Core collection data provided in Table 1</li><li>Field Core Collection logs also attached to this report</li><li>Transferred cores under COC to ARI (COC attached)</li></ol>					
<b>QUALITY CONTROL ACTIVITIES (INCLUDING FIELD CALIBRATIONS)</b> <ul style="list-style-type: none"><li>Navigation checks done at NAID Channel Marker prior to initiating sampling.</li></ul>

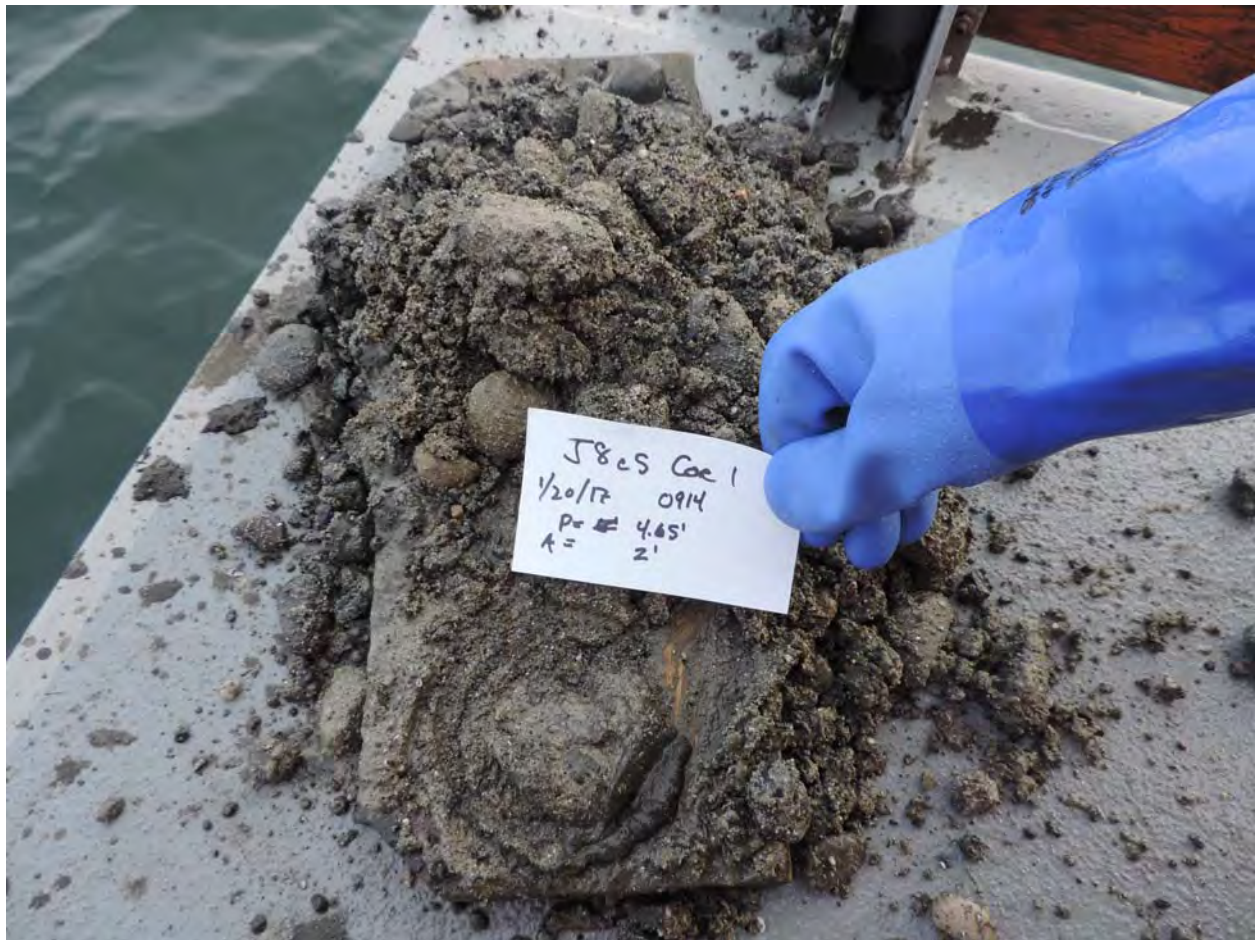
**Figure 1. Glacial till from rejected core at J8-c5**

Notes: 1' of till, minimal penetration
